CASE STUDY

Industry: Steel Industry
Customer: Steel Plant in Germany

▶ Handling a complex powertrain is not a problem for Off-Highway Powertrain Services

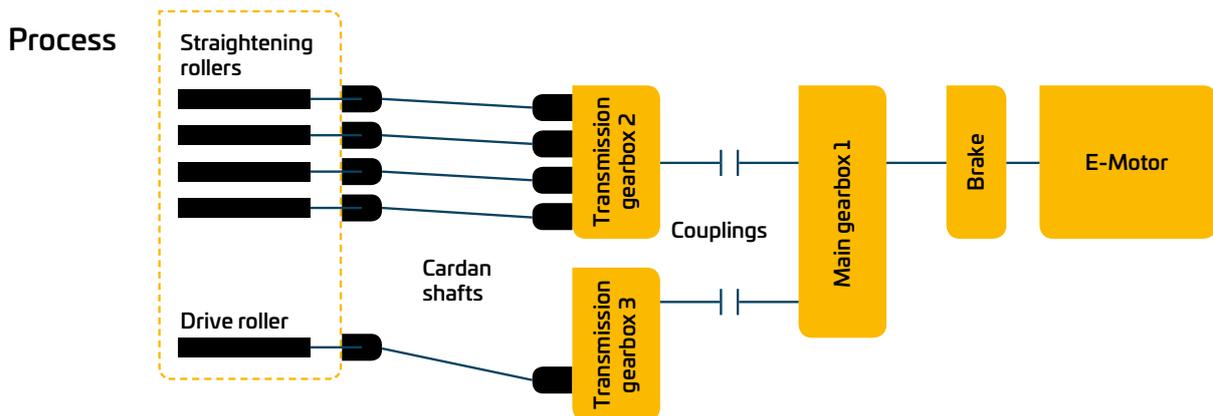
In fact OHP Services found that the cardan shafts were properly aligned and installed and were not damaged. Instead, a significant mis-alignment was identified in the couplings between the main gearbox and a transmission gearbox (see figure below). OHP Services, as a complete solution provider, reacted immediately on the findings to perform a corrective

alignment procedure on this complex powertrain the very next day. This was a technically difficult alignment since the main gearbox is a fixed, immovable installation. Therefore, the transmission gearbox needed to be adjusted, whilst at the same time it was essential to maintain the cardan shafts in alignment. The customer was also informed that the effect of the thermal growth in the powertrain must be considered to prevent possible misalignment when the powertrain is in normal operation.

One of our specialists monitored the production process during a work shift to check for thermal growth in the powertrain and was able to adjust for this factor during the alignment process.
