CASE STUDY

Industry: Food and Beverage
Customer: Dairy in Germany

**POWERTRAIN SERVICES**

▶ Vibration measurement in a dairy application with an unexpected finding

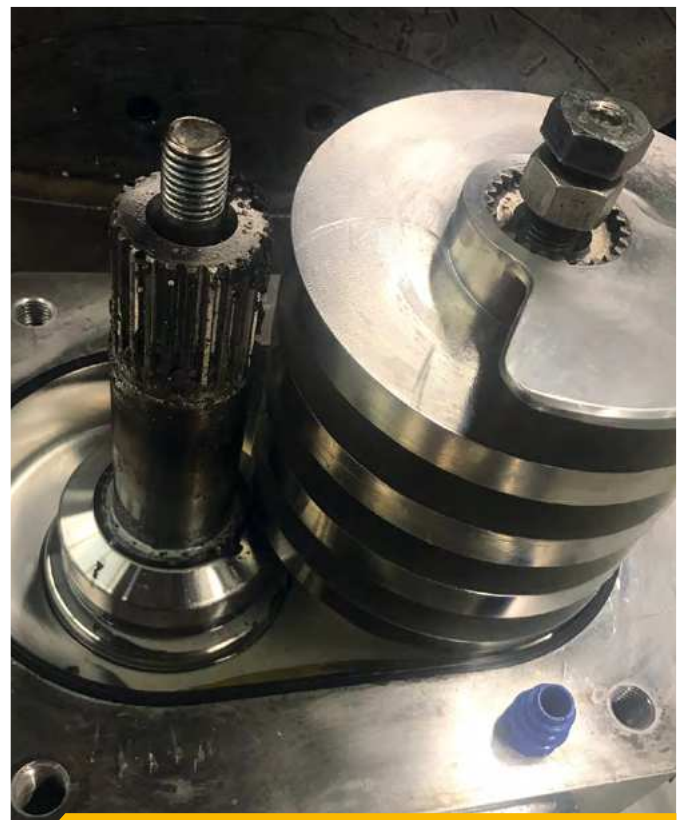
Our experts ensured the customer was aware that increased vibrations and noise in high frequency areas are indicators of progressive attrition within the bearings of a pump. During the cleaning process different liquids with different viscosity cause variations in pressure which leads to a decreasing capacity. As a result the control system tries to compensate for this through increasing the operating speed of the pumps. In only a short-time capacity fluctuations occur, however the control system of the engine is not capable to compensate for these fluctuations and consequently an error message appears.

In addition, due to the higher speed of the pump the risk of attrition increases. A statement about the exact condition of the pump and the bearing life is not possible therefore, the recommendation was to replace the pump as soon as possible. In order to be able to detect such damages earlier and prevent excessive ordering of spare parts OHP

Bearing damage of a spiral pump

Services recommended that in future preventive maintenance by means of vibration analysis is undertaken.

- ▶ Replace the pump immediately to prevent progressive wear and shrinkage of the bearing surfaces of the worn wheels
- ▶ Preventive maintenance by means of vibration analysis to detect damages earlier
