CASE STUDY

Industry: Rail Industry
Customer: Maintenance provider in Germany

▶ Case Description

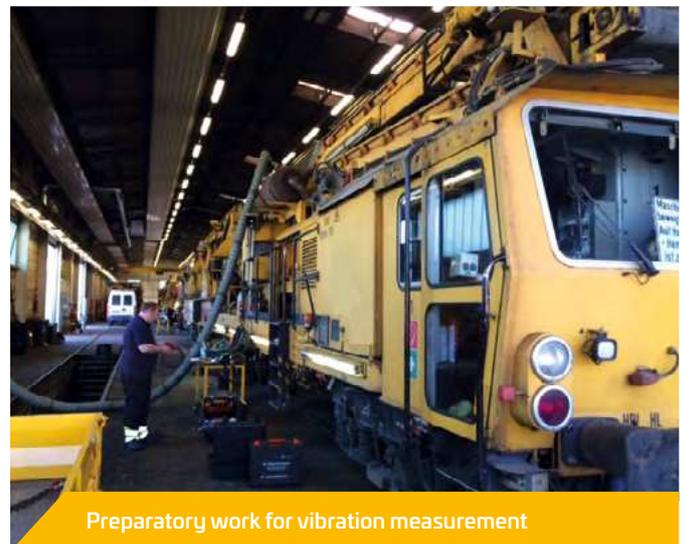
Different technologies like vibration measurement, thermographic measurement and alignment check are used to get to the root cause of the problem. A multi-channel vibration measurement system was used for the vibration and natural frequency analysis. Sensors were installed at different positions of the machine to record

these measurements. Detailed reports with hard facts were generated to support maintenance decision making. Main advantage of this service is early identification of fundamental powertrain faults leading to minimised risk of unplanned downtime.

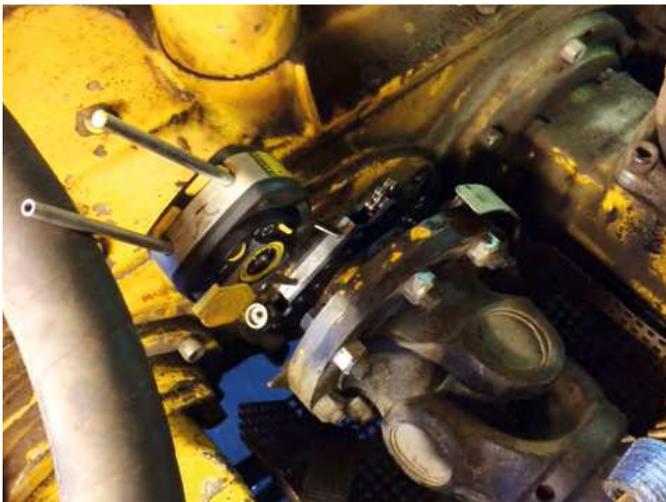
Checking the alignment of the flange parallelism
