CASE STUDY

Rail Industry
Rail operator in Israel

► Off-Highway Powertrain Services solves a systemic problem impeding the customer for past 6 years!

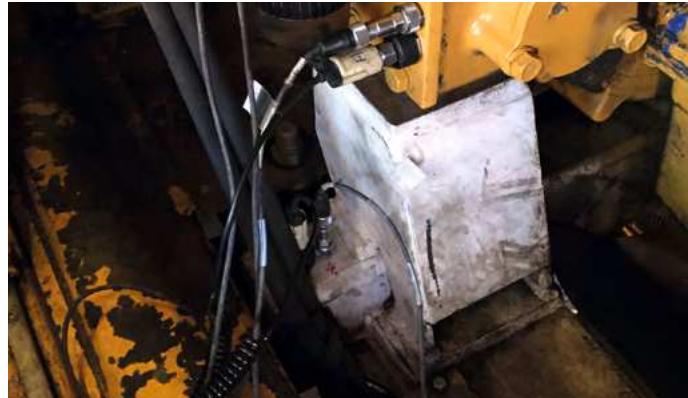
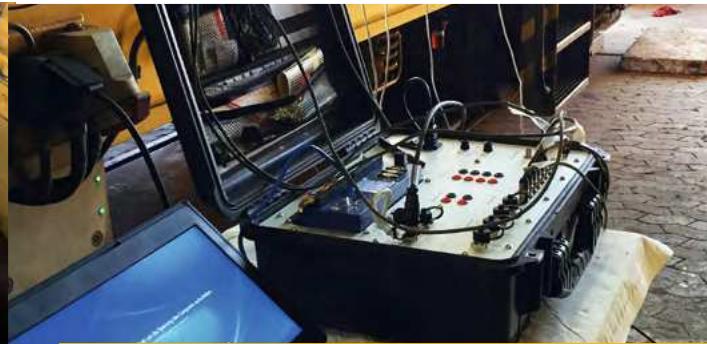
Multi Channel Measurement

A telemetry unit is used for torque measurement on a rotating transmission shaft. The torque telemetry has a rotating element on the shaft that obtains the torque-induced strain from a strain measurement electronic device. The torque signals can be provided to the vehicle control network (e.g. CANBUS) or directly to a data acquisition system (depending on the existing infrastructure and the project requirement).

The torsional natural frequencies for this application were evaluated by our experts.

Off-Highway Powertrain Services (OHP Services), who was the product supplier, offered to investigate the problem. Our service experts performed vibration analysis on the diesel engine and torque measurement on the BPP for two trains and compared the results to calculate the operating loads on the cardan shaft.

The torque measurements had very high variances on the alternating torque amplitude, significantly above the allowable limit for the cardan shaft being used. Therefore the lifetime of the cardan shaft was limited.

Also, the vibration analysis clearly indicated non-uniform speed output of cardan shaft caused by misalignment. This would increase wear and accelerate breakdowns.
