Industry: Plastics
Customer: PVC producing company in Germany

▶ Shaft-Voltage measurement in the plastics industry in Germany

▶ Case description:

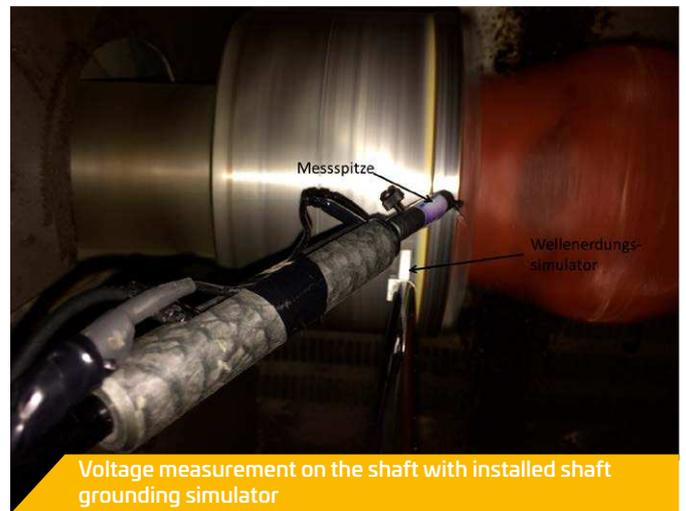
Voltage measurement on the shaft with installed shaft grounding simulator

For measuring the shaft voltages a digital oscilloscope with special probes and a grounding-ring-simulator is used. At first the voltage trend is measured on the shaft to check if there are voltages and how they build up during the use of the machine. In a second measurement the grounding ring-simulator is mounted on the shaft to check the effectiveness of the shaft grounding.
